**CANINE INVESTIGATIONS FOR SOURCE TRACKING OF  
HUMAN SEWAGE CONTAMINATION IN THE NAVESINK RIVER  
MONMOUTH COUNTY, NJ**

Prepared For:  
**Clean Ocean Action**  
18 Hartshorne Drive  
Highlands, NJ

Prepared By:  
**Environmental Canine Services LLC**  
39 Bow Street  
Otisfield, ME 04270

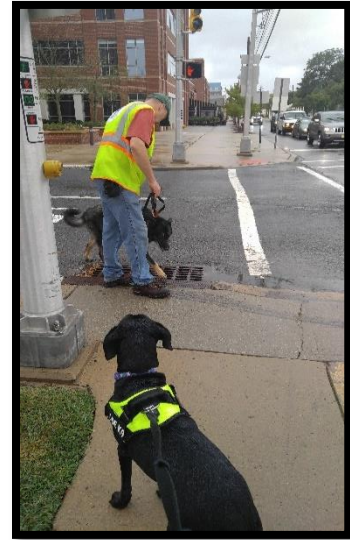
of outfall 14. They determined that some branches of the stormwater system were not a source of human sewage pollution by not alerting at catch basins or manholes in those branches. The locations where the canines alerted to the presence of human sewage contamination are listed below (Red Bank stormwater map numbers are used):

- a. Catch basin 4 near the corner of Wharf Avenue and Union Street.
- b. Manhole 36 at the corner of Mechanic Street and Globe Court.
- c. Manhole 44 on Wallace Street between Mount Street and Broad Street.

*Figure 2: Scott & Sable checking catch basin in Red Bank with Remi looking on Sept 19*

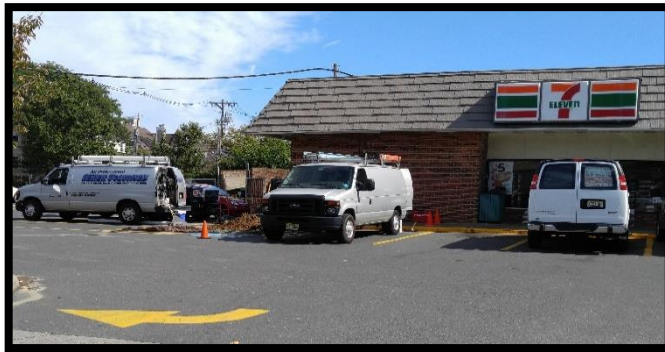
*Figure 4: Sewer or drain line repair on Sept 23 at 7 Eleven across the street from CB 141*

Note: While driving through Red Bank and passing the corner of Maple Avenue and Front Street on September 23, Karen and Scott Reynolds noticed that the 7 Eleven store across the street from catch basin 141 appeared to be in the process of having either a

sewer or drain pipe being serviced during that time. The service provider's vehicles were parked nearby in the lot. It was observed that the parking lot was dug up, and the water from the trench was flowing down the parking lot to the street. It was noted that a lateral line (#68 on the Red Bank sanitary sewer map) runs through the parking lot in that location to a sewer manhole next to catch basin 141. It is possible that the leakage from the lateral line seeps into catch basin 141 and is flushed through during rain events.

- Investigate a possible faulty sewer line along Front Street between Maple Avenue and Pearl Street, and/or faulty lateral lines from the buildings, particularly at the locations along the wall of the Rite Aid building alerted at by Logan.
- Investigate whether lateral line 68 from the 7 Eleven store across the street from catch basin 141 may have been leaking and was subsequently repaired on September 23.

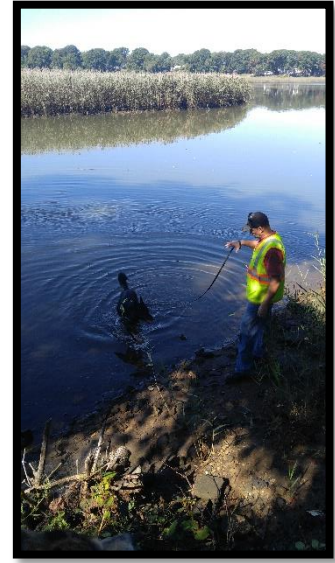
- a. Neither canine alerted at outfall 4 at the West end of Locust Avenue or two catch basins (2 and 3) in the street above the outfall.
- b. Neither canine alerted at the outfall at the West end of Bank Street.
- c. Sable, the only canine able to traverse with his handler to outfall 6 in the difficult terrain (steep hill, heavy vegetation) at the West end of Drs James Parker Boulevard, did not alert at the outfall.

*Figure 5: Sable swims in the Swimming River at the end of Locust Ave Sept 22 after not alerting at this site*

The stormwater systems that outfall to the Swimming River at Locust Avenue (outfall 4 on Red Bank map), Bank Street (outfall 5), and Drs James Parker Boulevard (outfalls 6 and 6A) were eliminated as potential sources of human sewage contamination based on no alerts from the canines when investigating these areas. The catch basin/outfall at the end of Chapin Avenue was a source of concern for greywater and/or human sewage discharges from the dumpster area of the nursing home across the street. Recommendations are as follows:

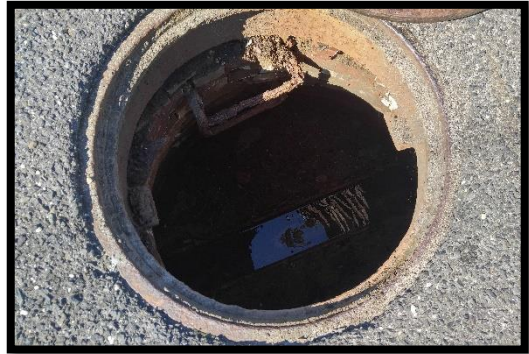
- d. Neither canine alerted at the next catch basin numbered 261 (catch basin 14 on Red Bank map) upstream in the stormwater system on Marion Street. There was less water flow. The catch basin depth, which is actually a drop inlet to the main stormwater line, is 6-8' deep. The adjacent sanitary line depth was 3-4' deep, and there was flow in the sanitary line and debris in the channel, with potential blockage.

*Figure 6: Shallow sanitary manhole on Marion Street Sept 22*

The sanitary infrastructure in this area appeared to be very old, with sinking manholes, and settling, erosion, and cracking noticeable along the pavement above the infrastructure. There may be sanitary line leakage between catch basin 264 and 261 which is seeping into the stormwater line below it.
- e. Neither canine alerted on catch basin 17 at the end of Marlin Place off of Mechanic Street. There did not seem to be any underground infrastructure at this location, and the catch basin was dry.
- f. Neither canine alerted at catch basin 18 at the intersection of Marion Street and Worthley Street. A resident at a house at that intersection stated that the stormwater system consistently backs up into that catch basin and floods the street during heavy rain.

- Investigate the sewer infrastructure on Marion Street between Harrison Avenue and Worthley Street for a possible broken/leaking sewer line.
- Investigate the stormwater infrastructure on Marion Street between Harrison Avenue and Worthley Street for infiltration of sewer discharges and for possible broken lines causing malfunction of stormwater runoff from upstream.

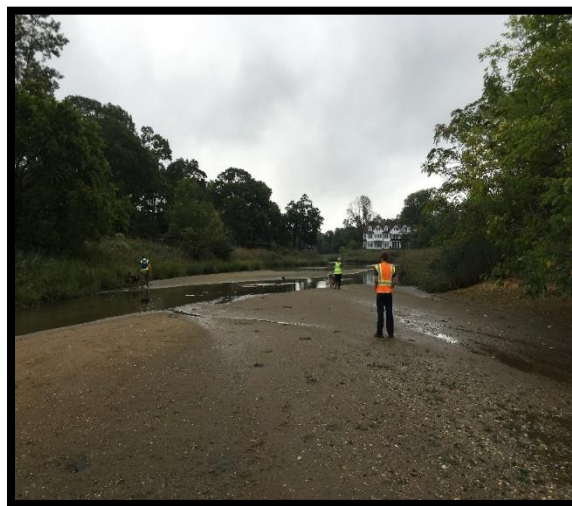
- b. Both canines alerted at the driveway of 715 River Road where Fourth Creek crosses under the driveway. Sable investigated the creek to the North of this location and alerted on a broken old clay pipe on the West side of the creek.

- c. Both canines alerted at a PVC pipe in Fourth Creek next to the parking lot of The Commons at 740 River Road. The pipe was connected to a catch basin in the parking lot at the bank of the creek, and both canines alerted at the catch basin. There was greyish looking water in the catch basin but not enough to sample. Logan investigated and alerted at a nearby trash dumpster with greyish water and grease stains around it that appeared to have flowed downhill into the catch basin. The canine alerts at the pipe and catch basin may be due to the presence

*Figure 7: Scott/Sable and Karen/Logan investigating Fourth Creek at low tide Sept 20*

of greywater components leaking from the dumpster. Sable investigated the creek immediately upstream of The Commons and did not alert.

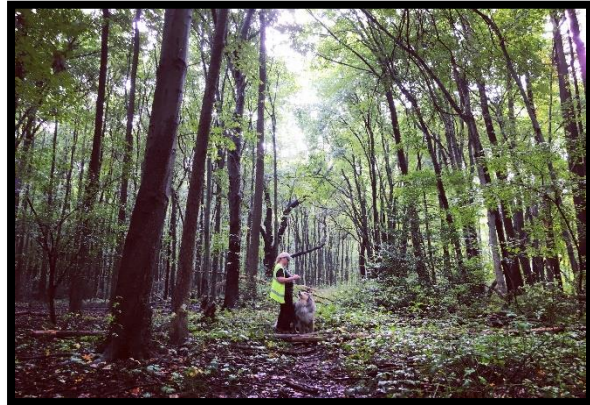
- h. Both canines alerted at catch basins FH-4 and FH-5 at the creek crossing on McCarter Avenue.
- i. The canines investigated the creek bed in the Fair Haven Fields Natural Area from where it originates at Dury Pond. Logan alerted on the east side of the creek bed downstream of the pond. He investigated the ground above the east side of creek bed, both north and south of the alert site and alerted along the ground in a straight line in a defined area from near where a small bridge crosses the creek south to near where a marked sanitary manhole is located. A review of the sewer line map in that area showed that Logan had alerted on the ground directly over the sewer line (between 290 and 291 on Fair Haven sewer line map), which indicates a potential sewer line leak at that location. Sable investigated the creek downstream of this location and alerted in several locations.

*Figure 8: Logan alerts on the ground above the sewer line in Fair Haven Field Natural Area Sept 20*

- Investigate a possible sewer line leak in Fair Haven Fields Natural Area between 290 and 291 on Fair Haven sewer line map. The consistent and strong canine alerts from this area all the way downstream to the Navesink River indicate that the leakage is likely significant and therefore should be given high priority for follow up investigation.
- Follow up with owners of The Commons at 740 River Road to ensure that detergents and/or fats/oils/grease are being properly disposed of and not leaking from the trash dumpster site in the parking lot downhill into Fourth Creek.

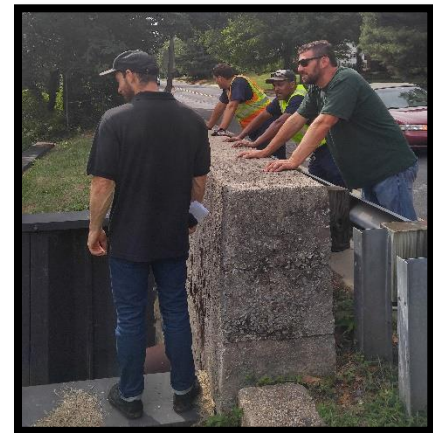
- a. Both canines alerted on a water sample collected by the NJDEP at the spillway and alerted at the spillway itself.
  - b. The Schwenker's Pond spillway flows to Shippees Pond, which flows to the Navesink River. The canines investigated a portion of the Shippees Pond shoreline from the back yard of a residence near the end of Laury Drive, near the Laury Drive outfall and alerted at that location. It was not possible to access Shippees Pond from any other locations.

- c. Both canines alerted at the culvert on the north side of River Road that drains to Schwenker's Pond to Shippees Pond. The water in the culvert appeared to have an almost gelatinous film on the surface.

*Figure 9: COA, NJDEP, and Fair Haven personnel inspect the spillway at Schwenker's Pond Sept 20*

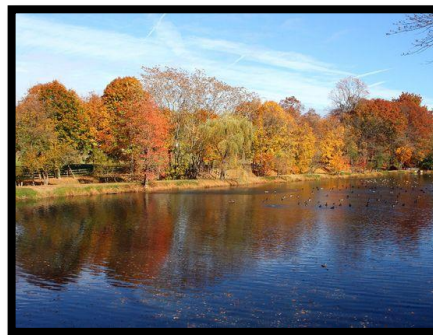
Figure 10: Haskell Pond

- d. Both canines displayed excited, agitated behavior and alerted very strongly at an old concrete trench structure at the southwest end of Haskell Pond (GPS 49.385745, -74.069199) on Whipporwill Valley Road along the main branch of the creek. There was a lot of very dark organic material in the trench, and some of the investigation personnel identified a sanitary-like smell. Information provided by a resident of the property was that an

old ice house had been at that location, and the concrete structures were part of its foundation. Neither canine alerted at the southeast side of Haskell Pond along the bank. Due to property access issues, the north side of the pond and the creek that drains to it on the west side could not be investigated.

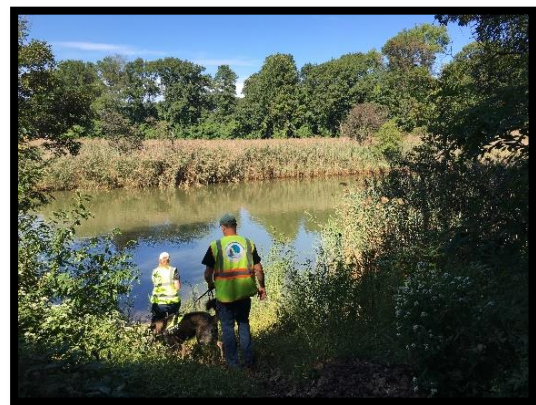
- a. Both canines alerted at the Shadow Lake spillway.
- b. Both canines alerted at the outfall to a tributary on Michael Drive near Joyce Lane.

*Figure 11: Sable and Remi investigate the Shadow Lake spillway Sept 23*

- Using stormwater and sewer system map information, investigate the stormwater and sewer systems in the private neighborhood that spans the north side of Shadow Lake for possible leaking sewer line or lateral line discharges.
- Using stormwater and sewer system map information, investigate the stormwater and sewer systems along the tributaries to the north side of the lake.
- Using stormwater and sewer system map information, investigate the stormwater and sewer systems in the residential areas and along the tributaries on the south side of the lake.

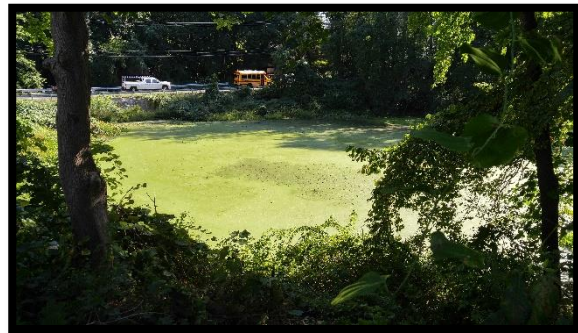
4. ***Green Pond Area*** – Investigations were conducted in the Green Pond area where a tributary flows to the Navesink River. The pond was covered with algae. Results of the investigations were as follows:

- a. Neither canine alerted at catch basins that drain to the pond on Green Lake Drive.
  - b. Neither canine alerted at the manhole on Arthur Drive.
  - c. Neither canine alerted at the catch basins on Grove Street.

**Figure 12: Green Pond Sept 23**

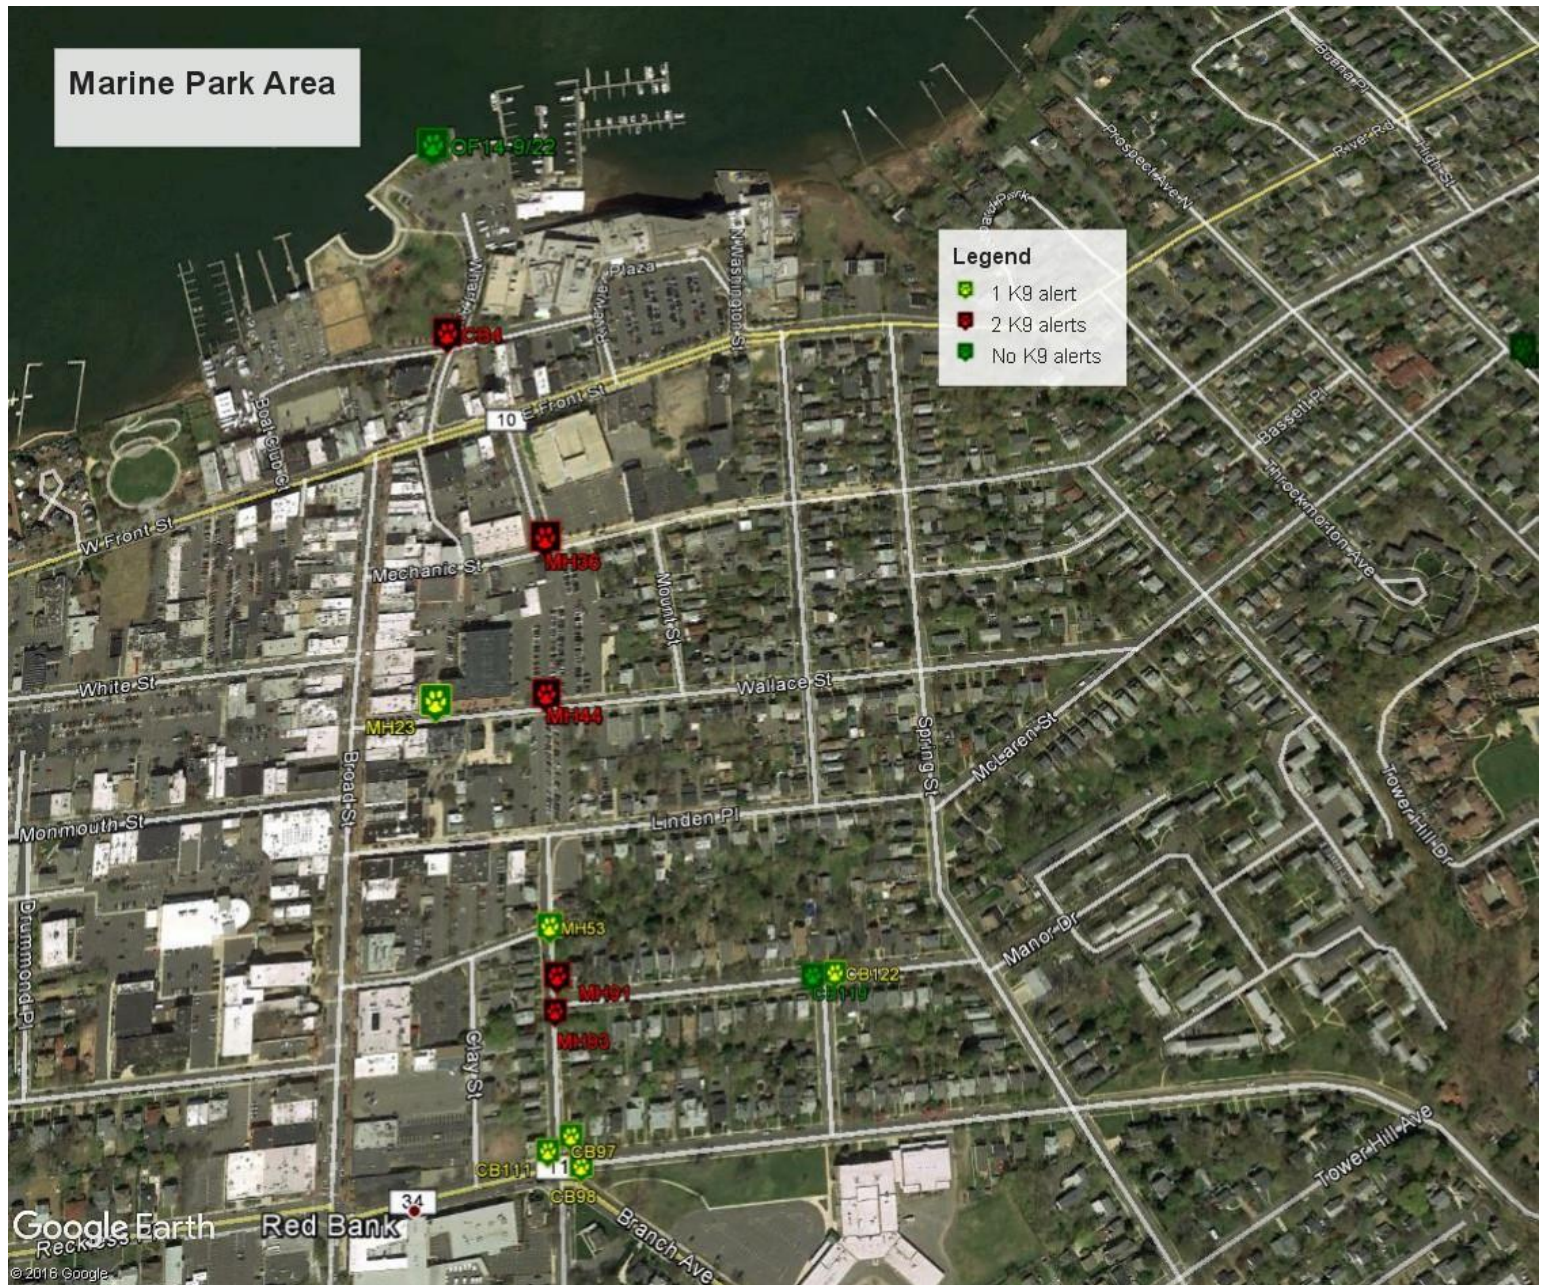
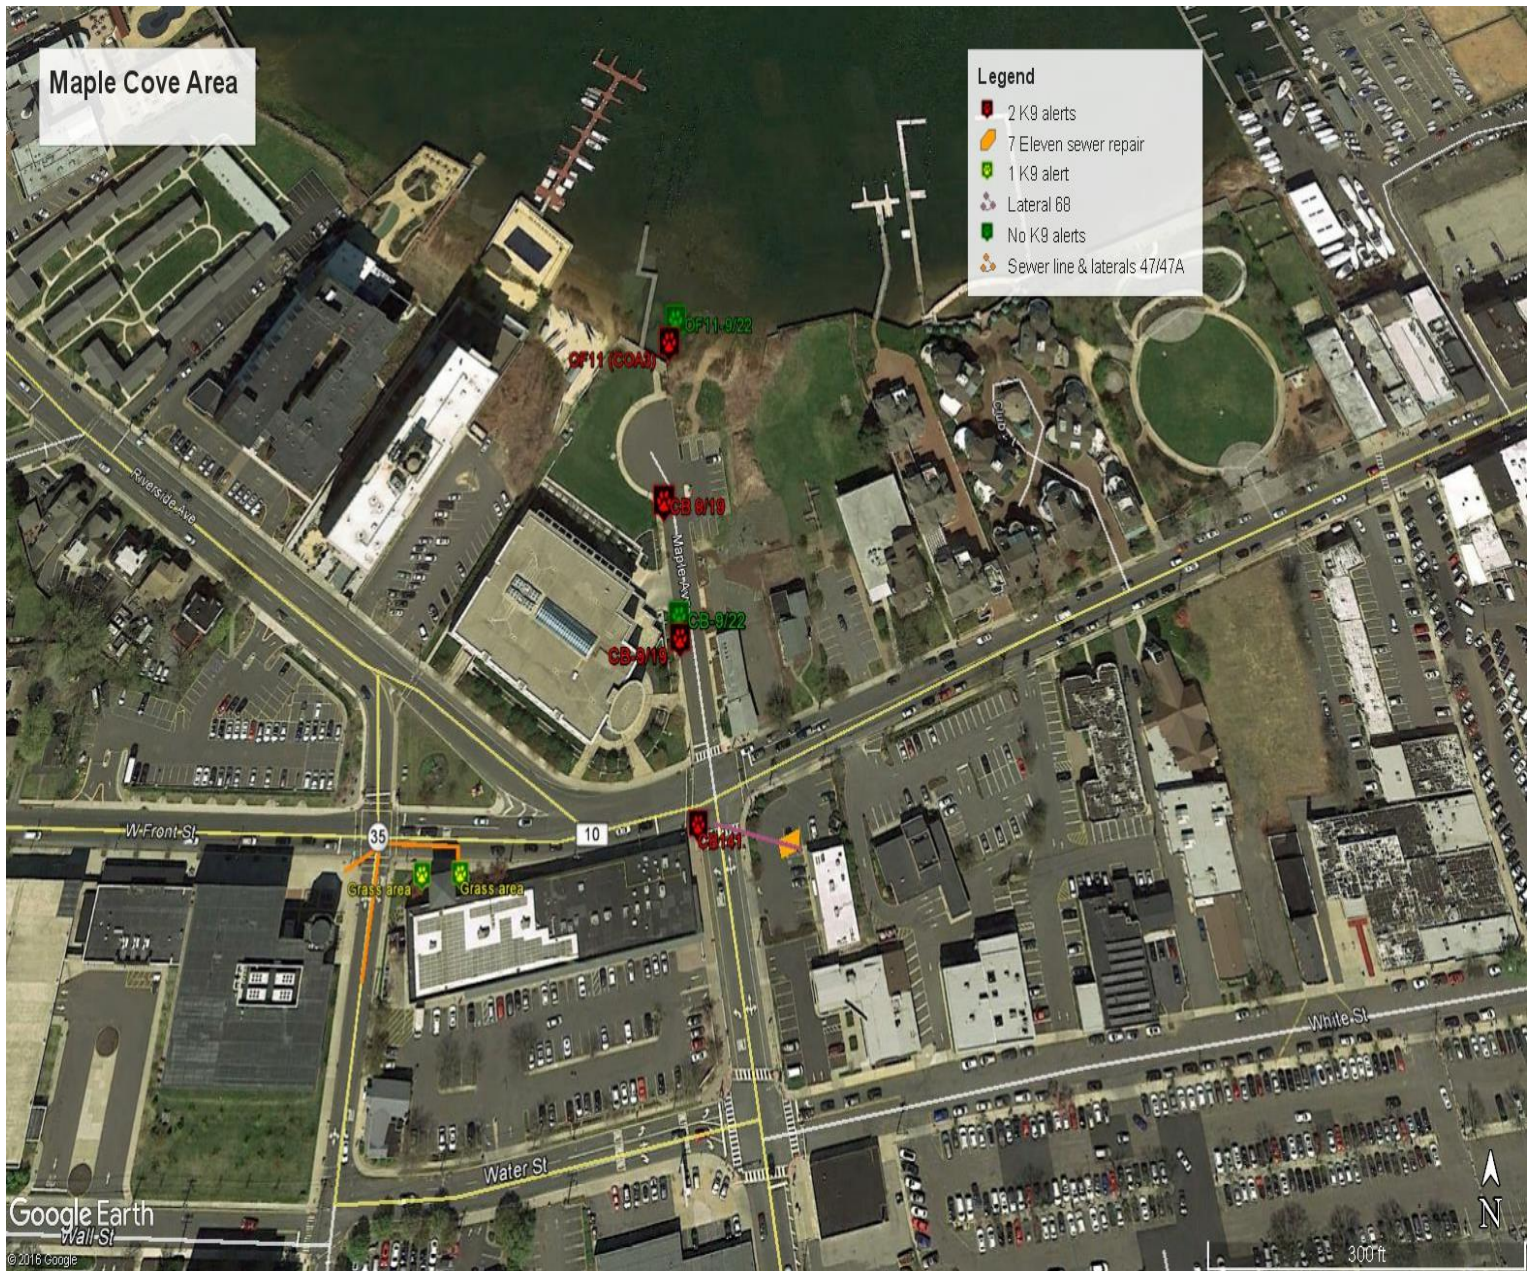
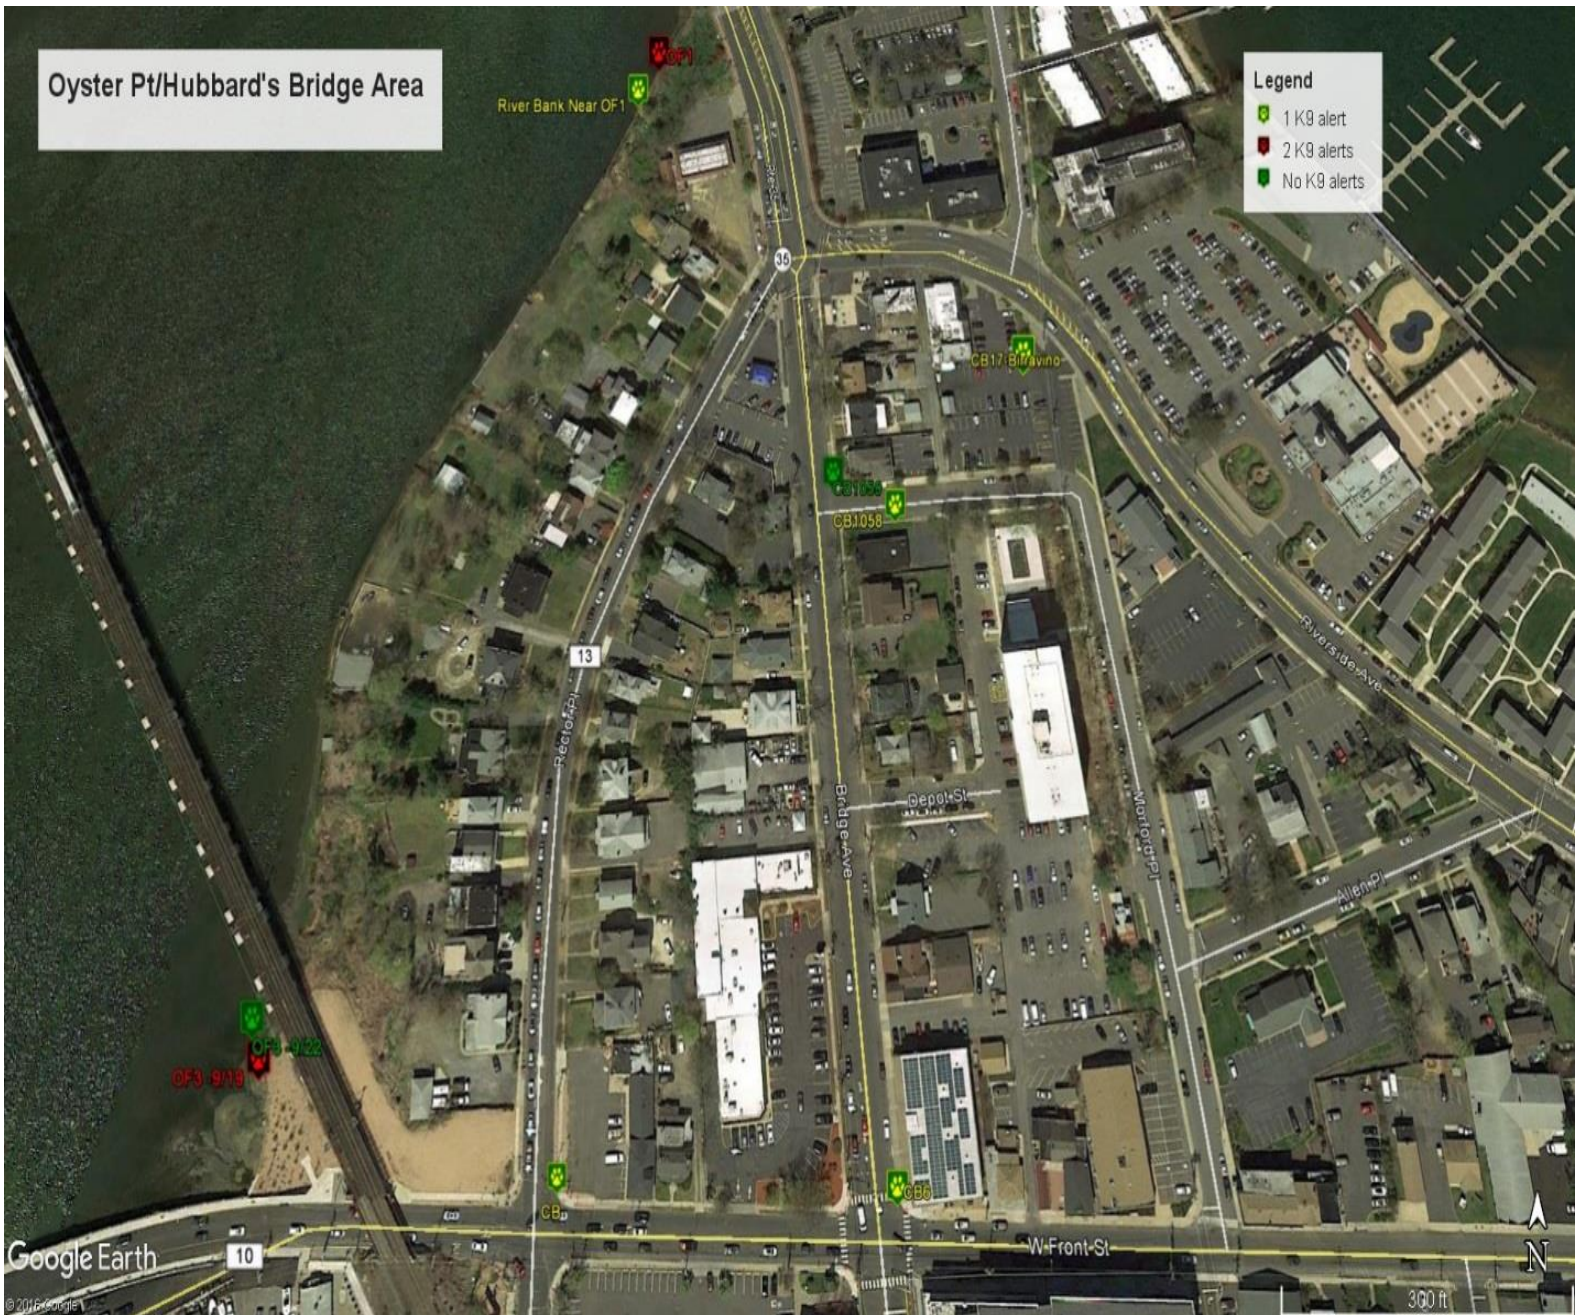
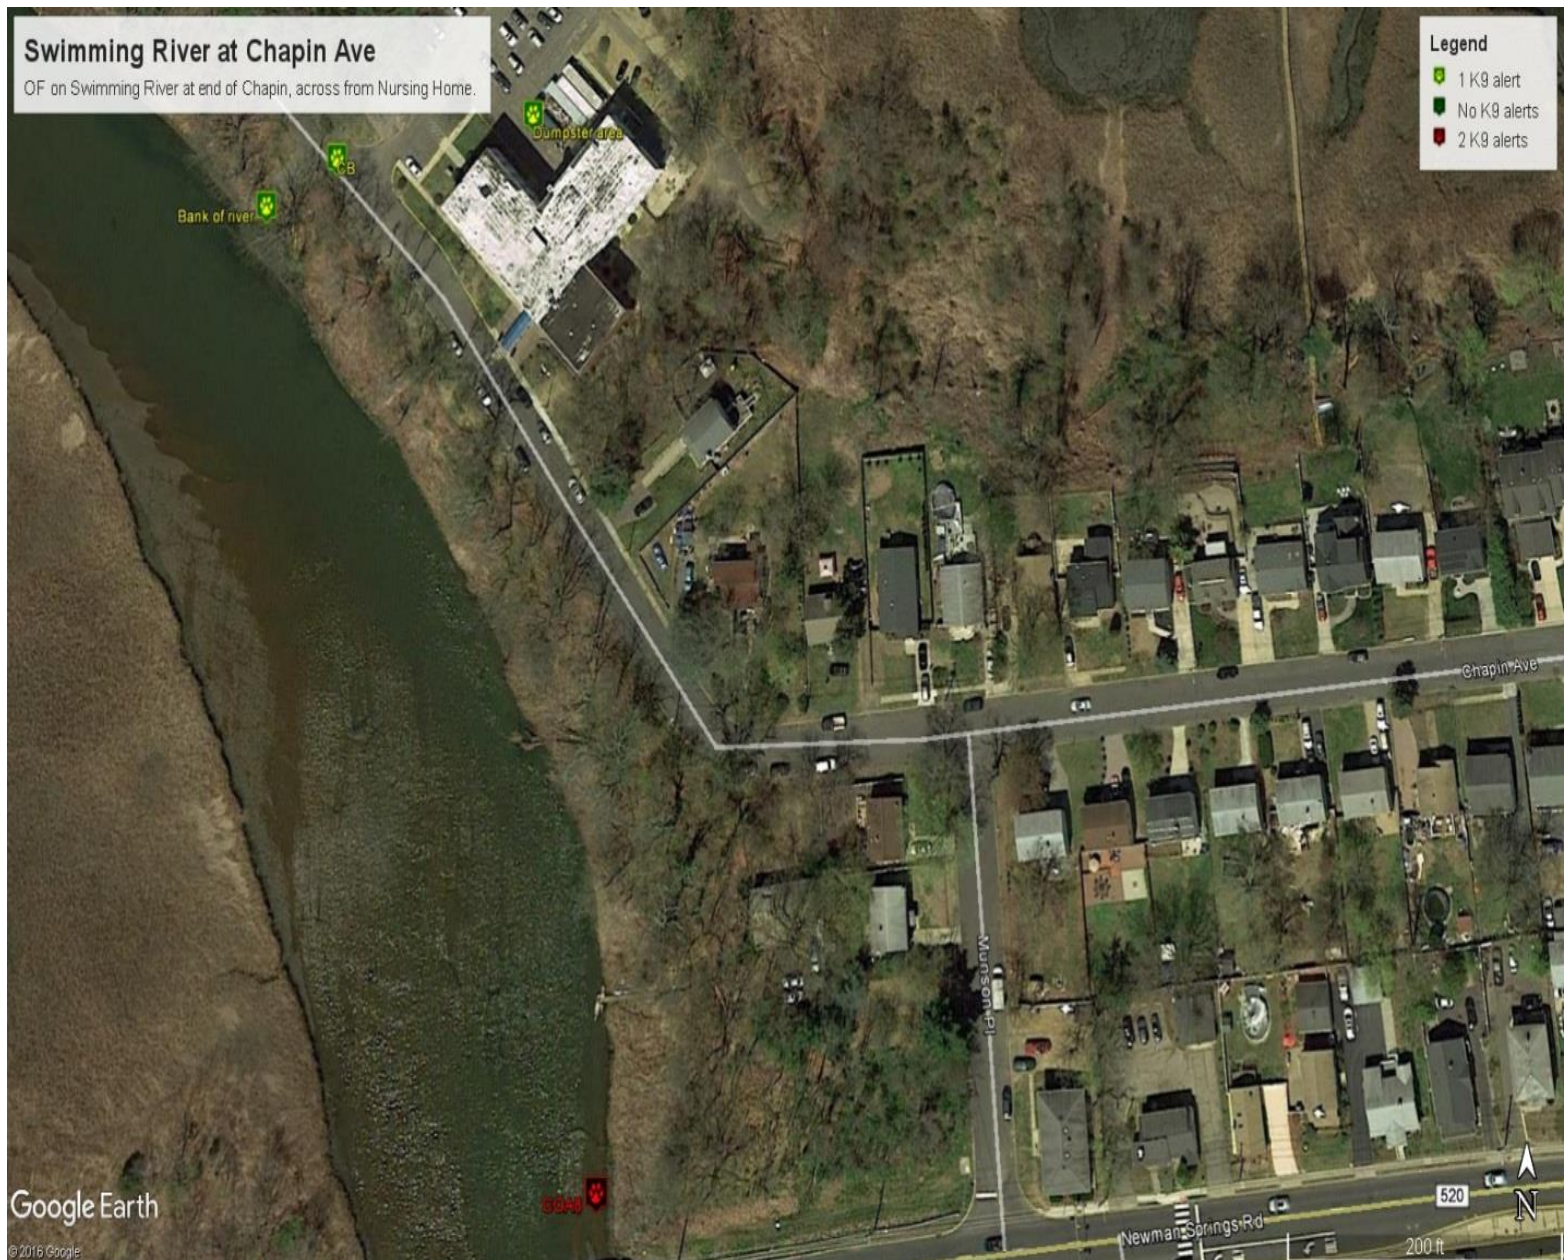
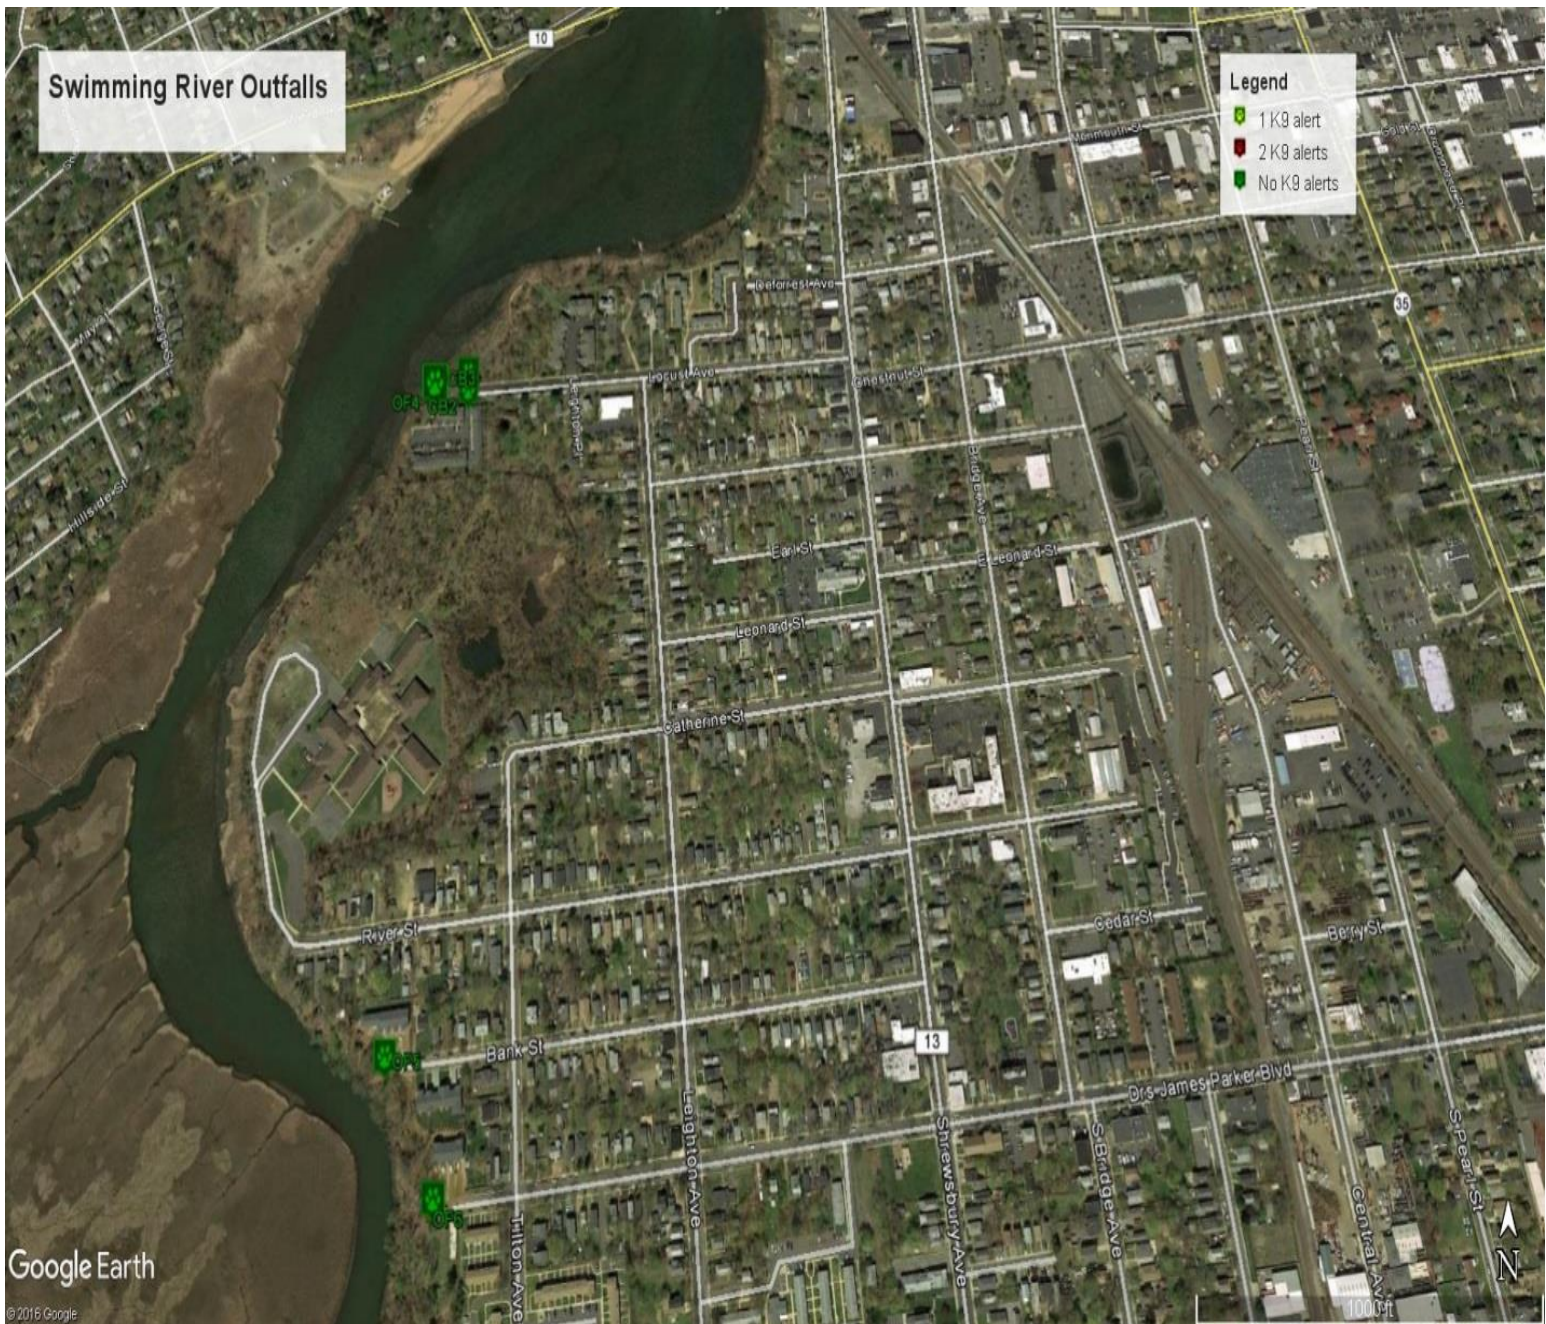
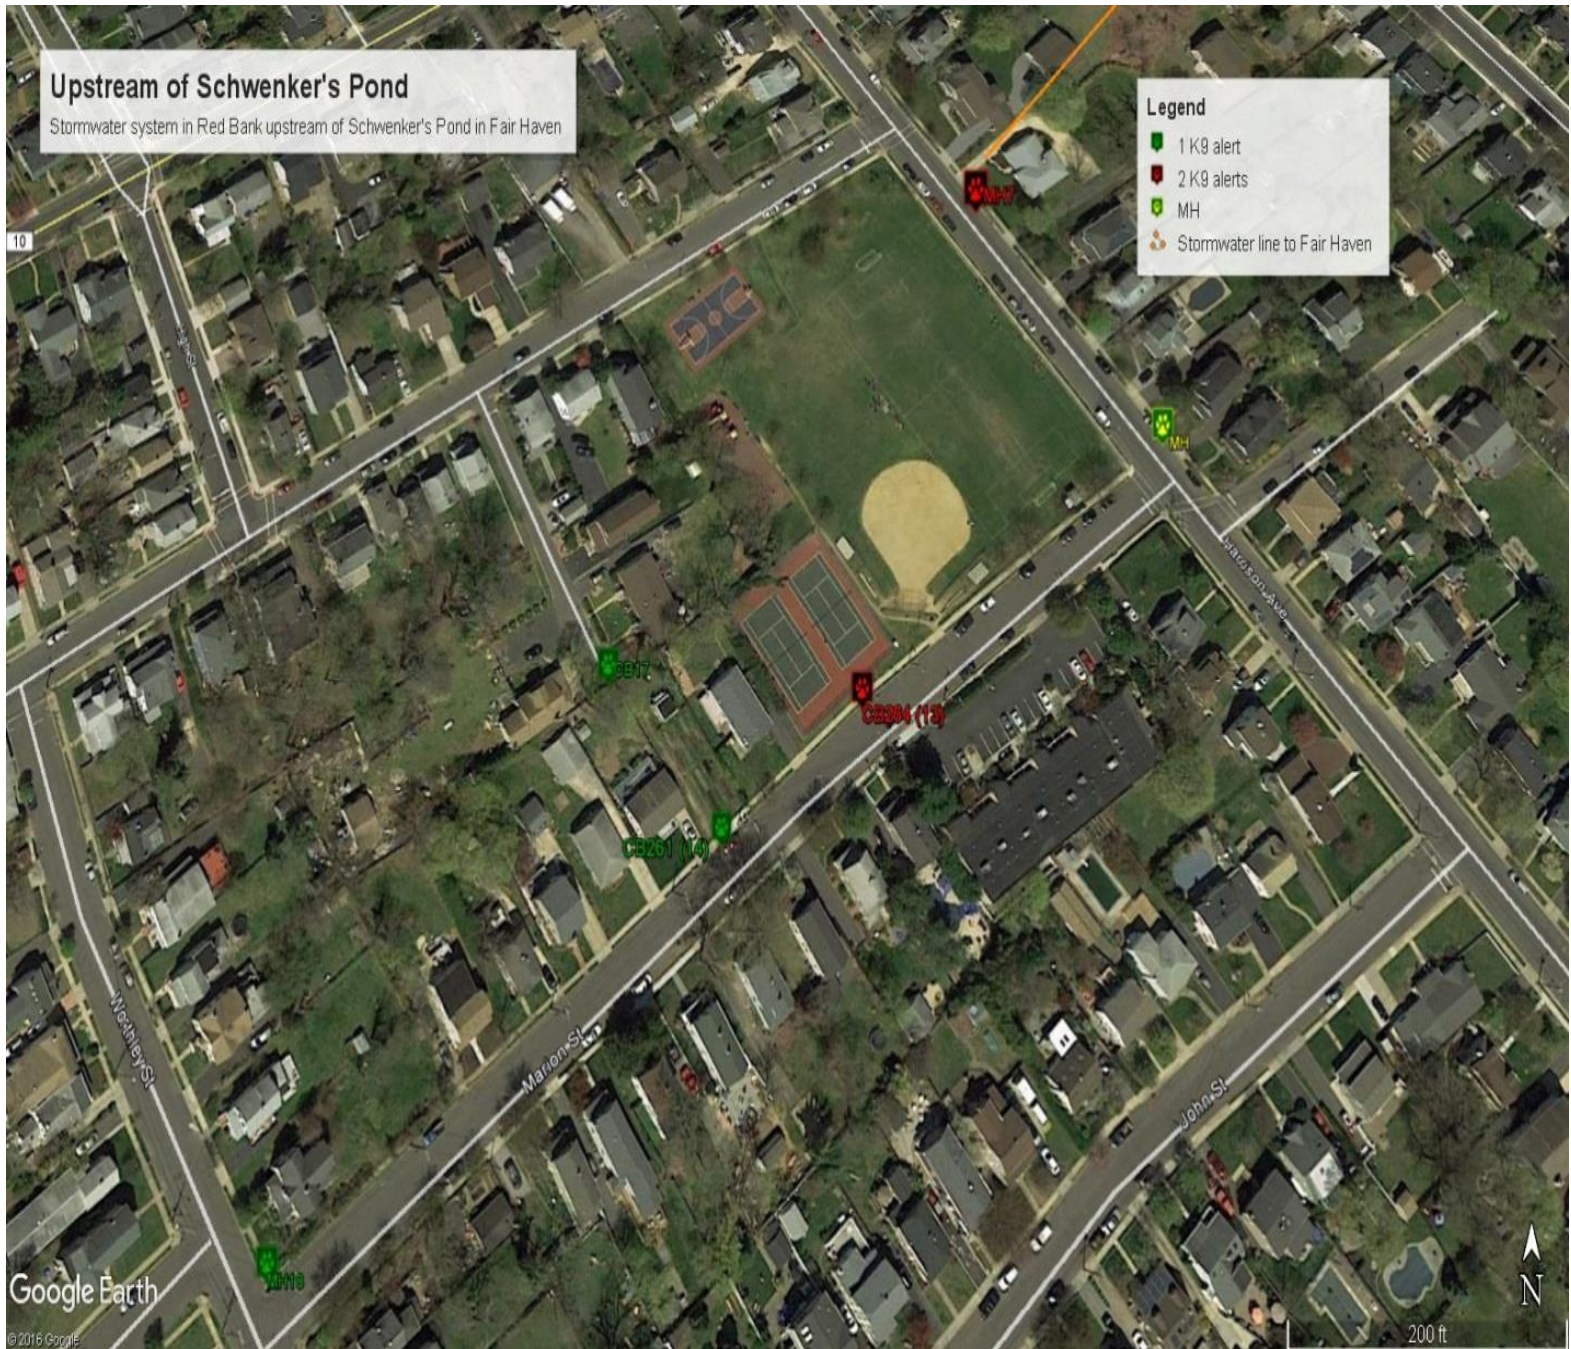
### Maps of Canine Investigation Results in Red Bank

Canine responses to each area investigated were mapped on Google Earth and analyzed along with the stormwater and sewer infrastructure maps provided by The Borough of Red Bank to determine where source tracking had either isolated or eliminated potential sources. The summary of these findings and recommendations and canine result maps are provided below:
