**CANINE INVESTIGATIONS FOR SOURCE TRACKING OF  
HUMAN SEWAGE CONTAMINATION IN THE NAVESINK RIVER  
MONMOUTH COUNTY, NJ**

Prepared For:  
**Clean Ocean Action**  
18 Hartshorne Drive  
Highlands, NJ

Prepared By:  
**Environmental Canine Services LLC**  
39 Bow Street  
Otisfield, ME 04270

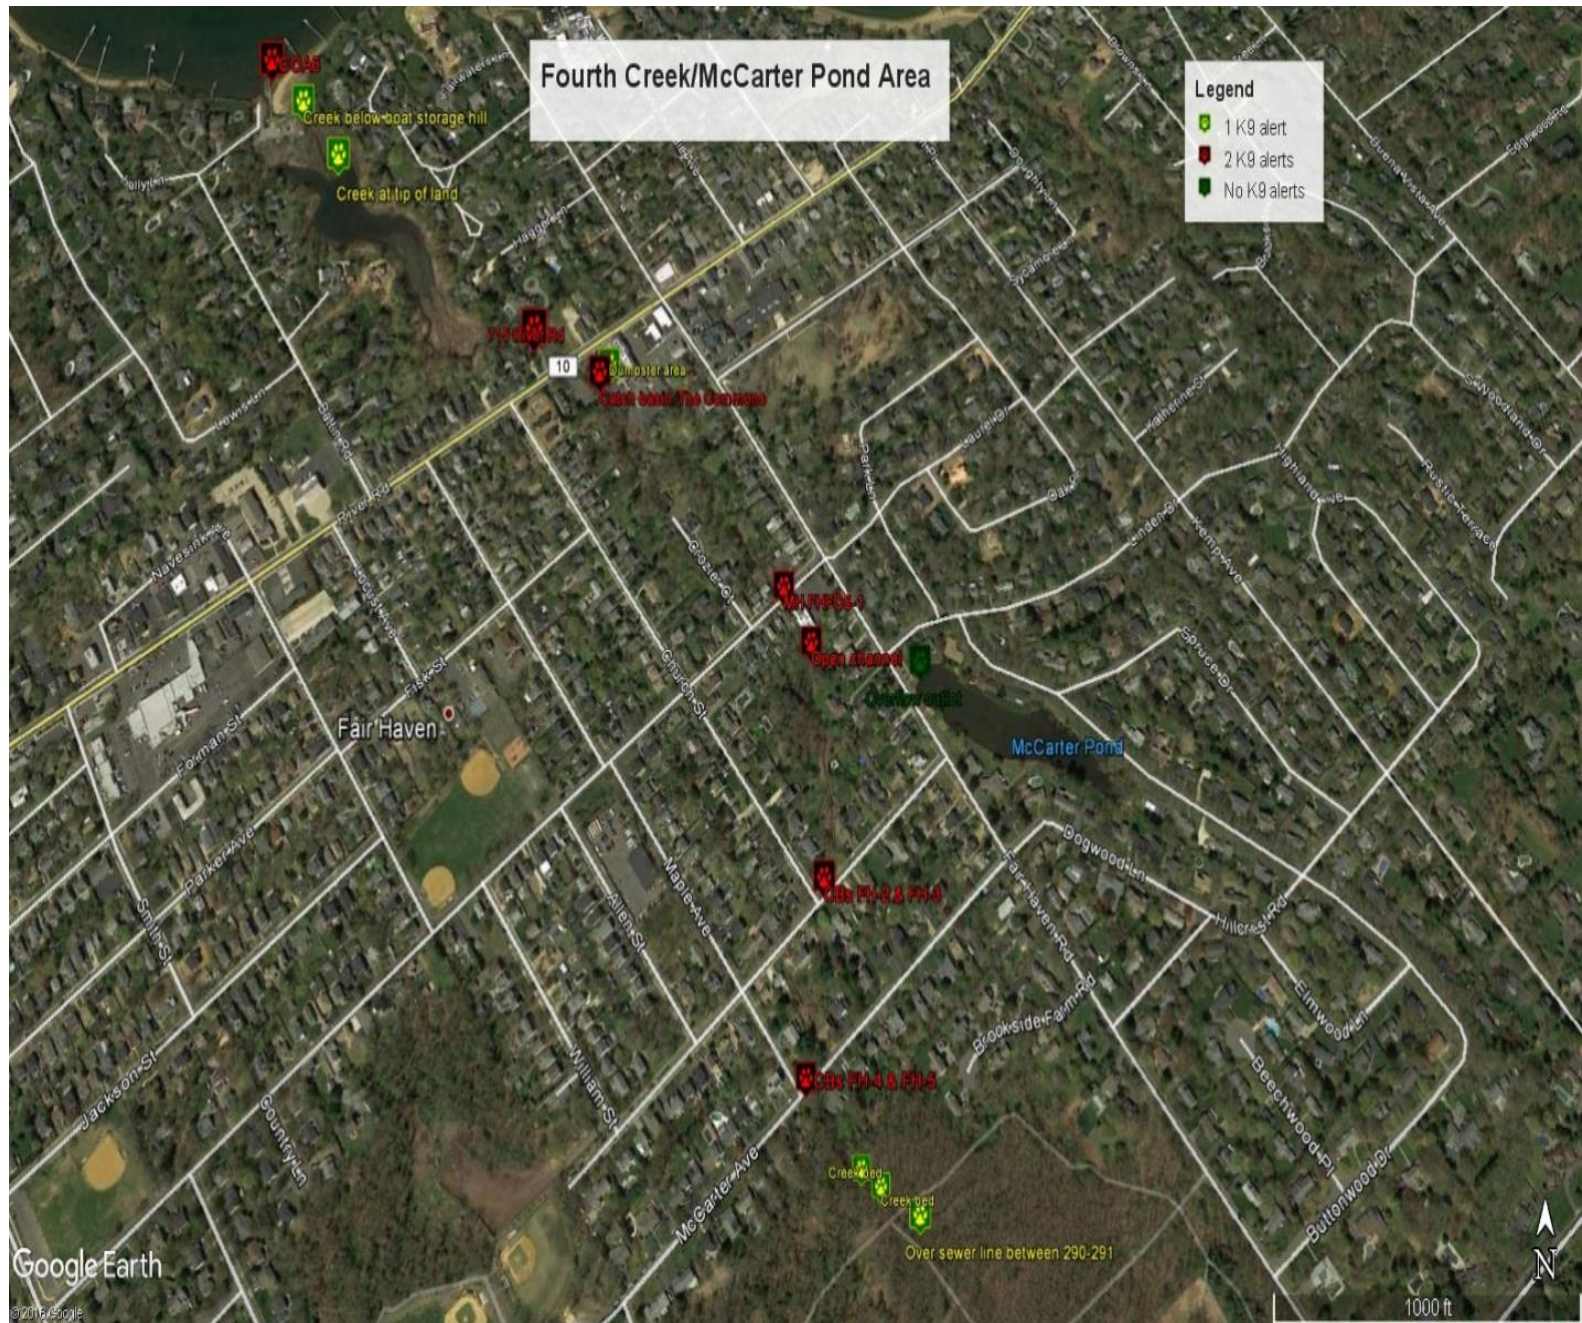
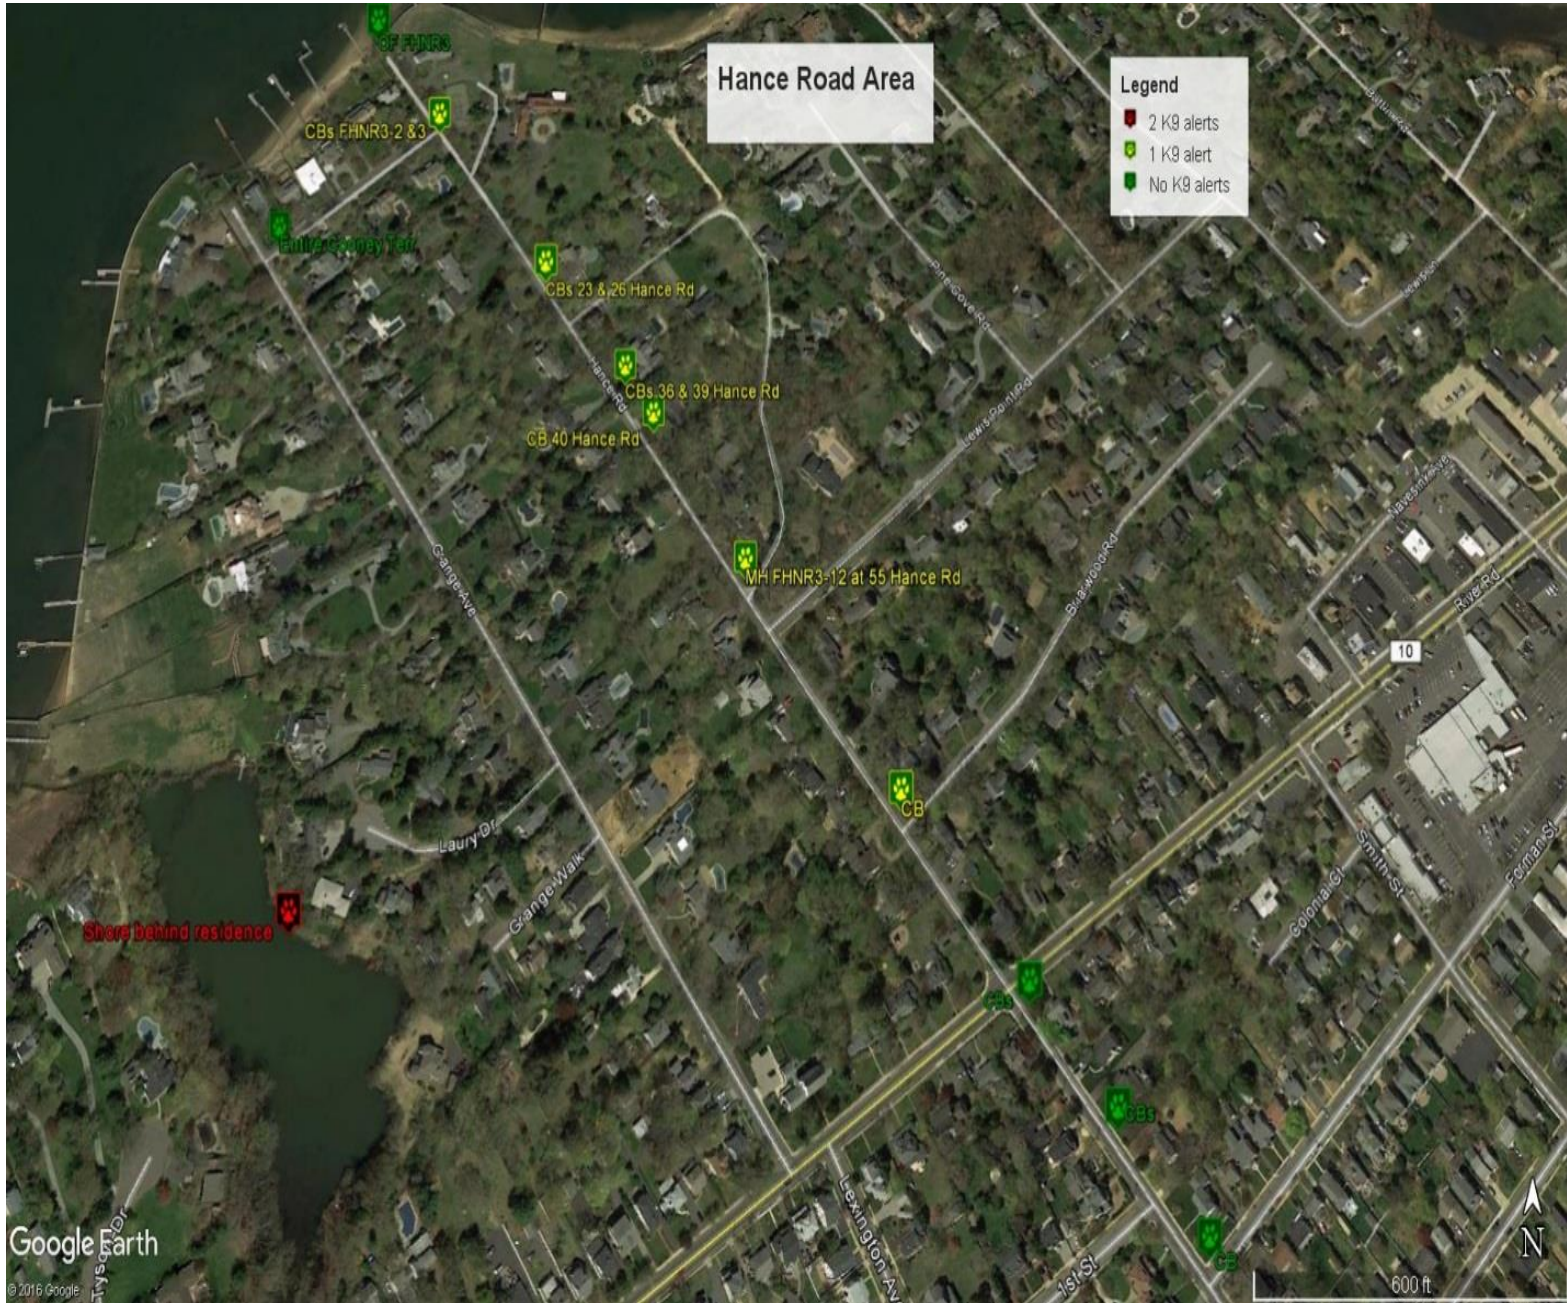
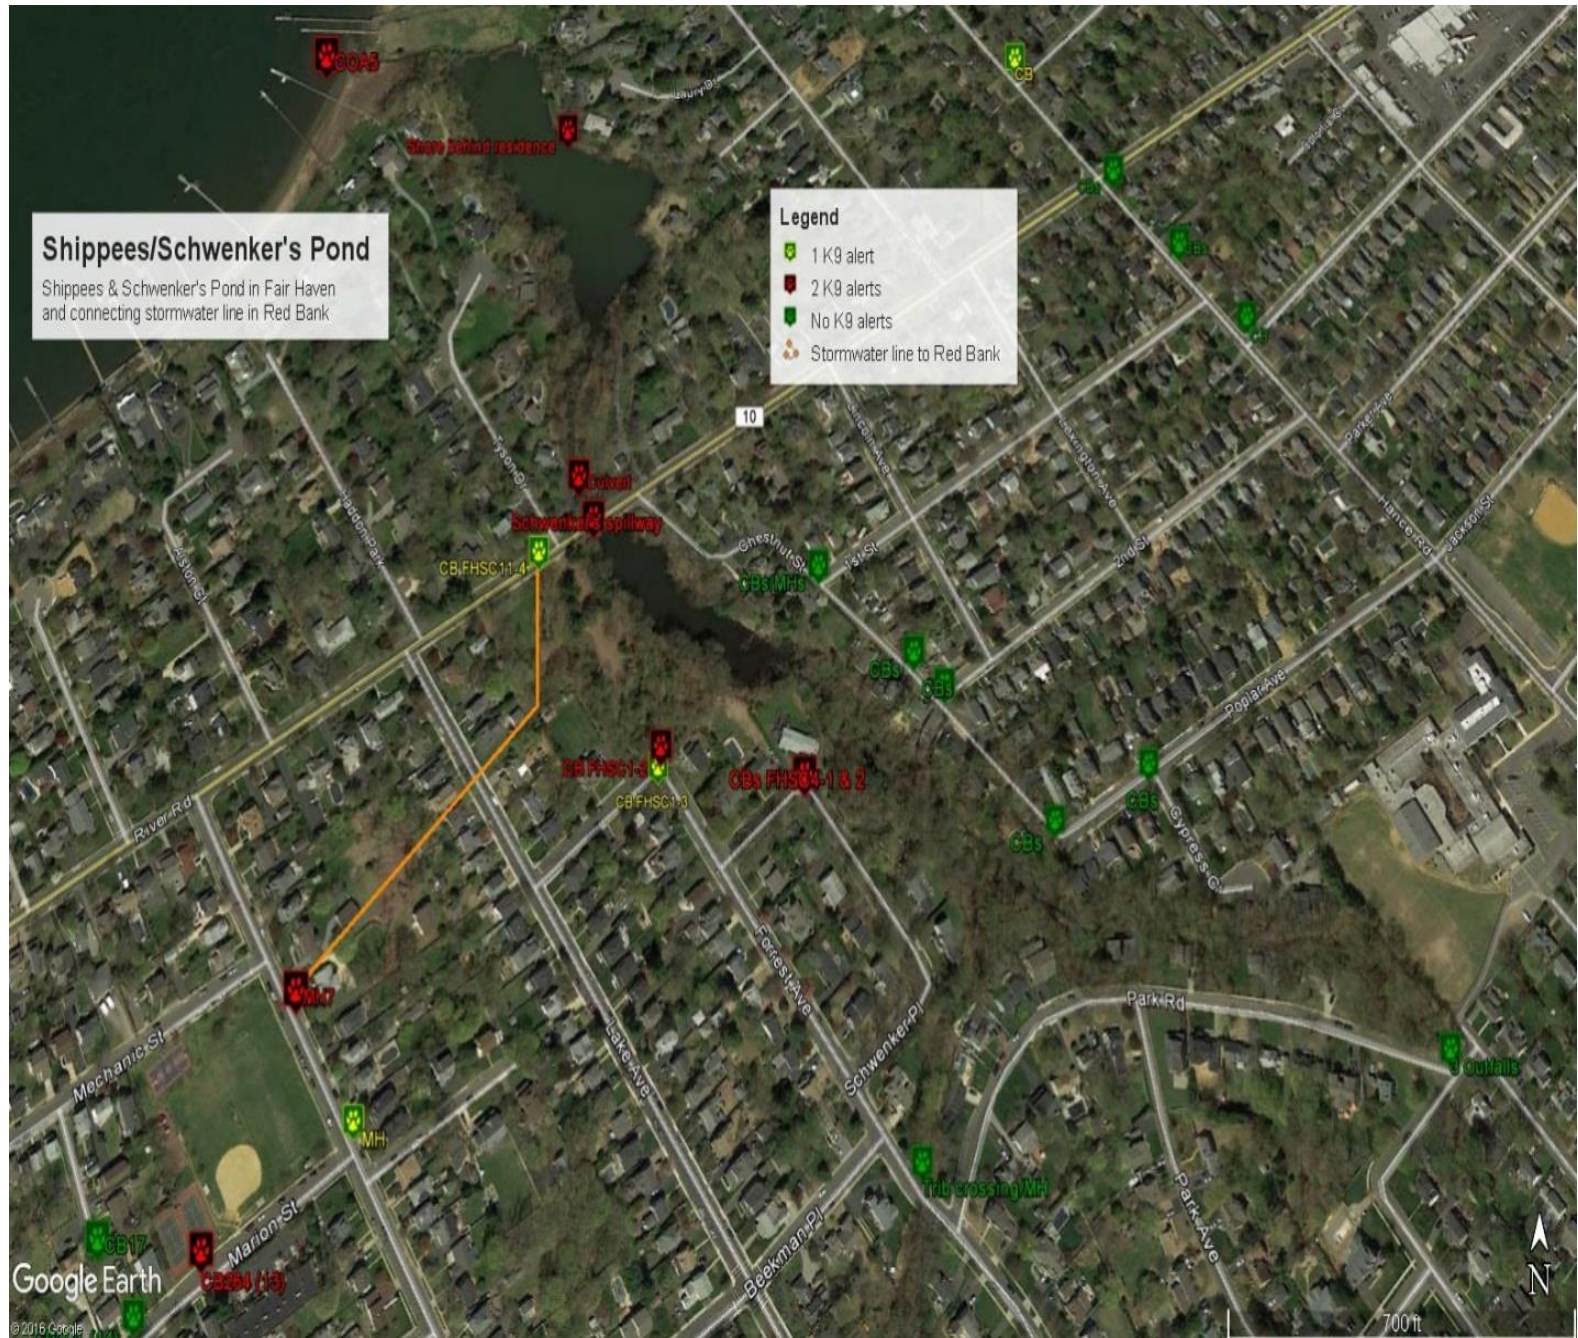
### Maps of Canine Investigation Results in Fair Haven

Canine responses to each area investigated were mapped on Google Earth and analyzed along with the stormwater and sewer infrastructure maps provided by Fair Haven to determine where source tracking had either isolated or eliminated potential sources. The summary of these findings and recommendations and canine result maps are provided below:

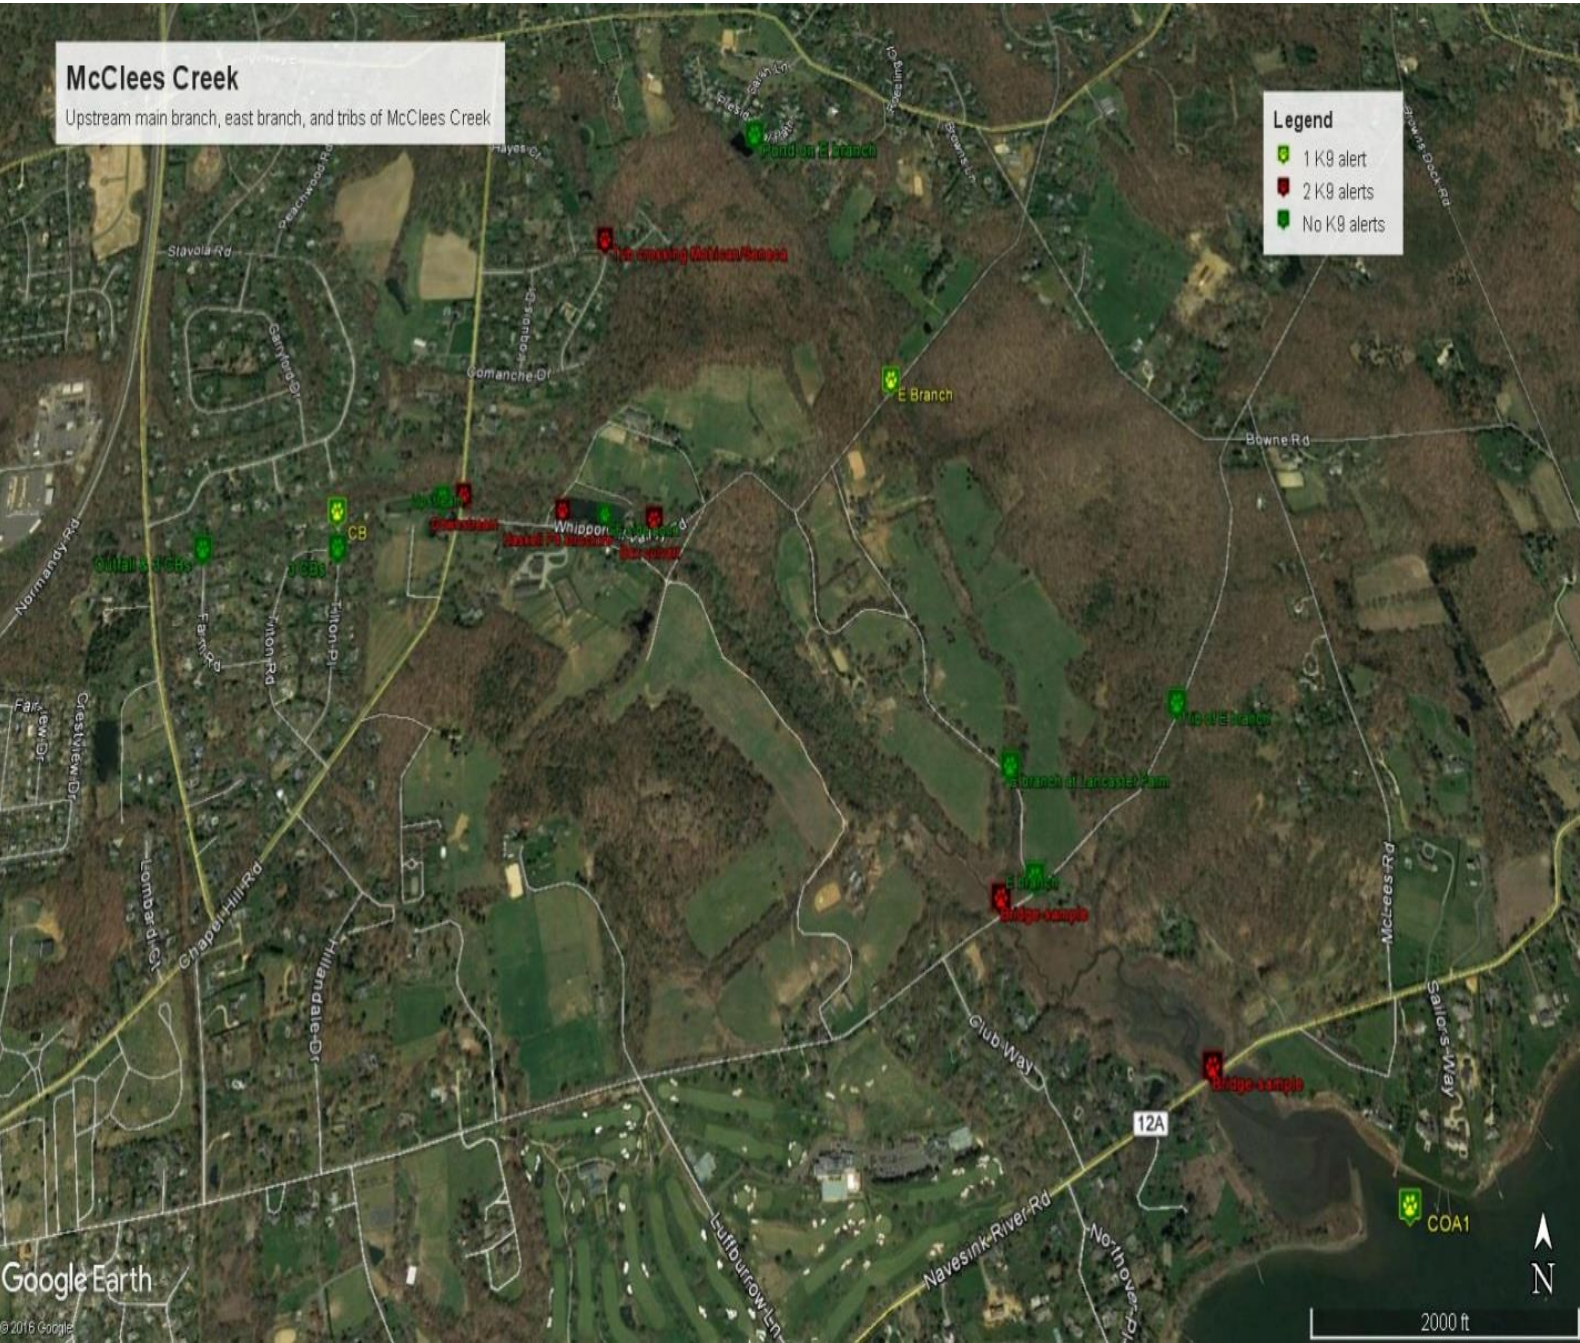
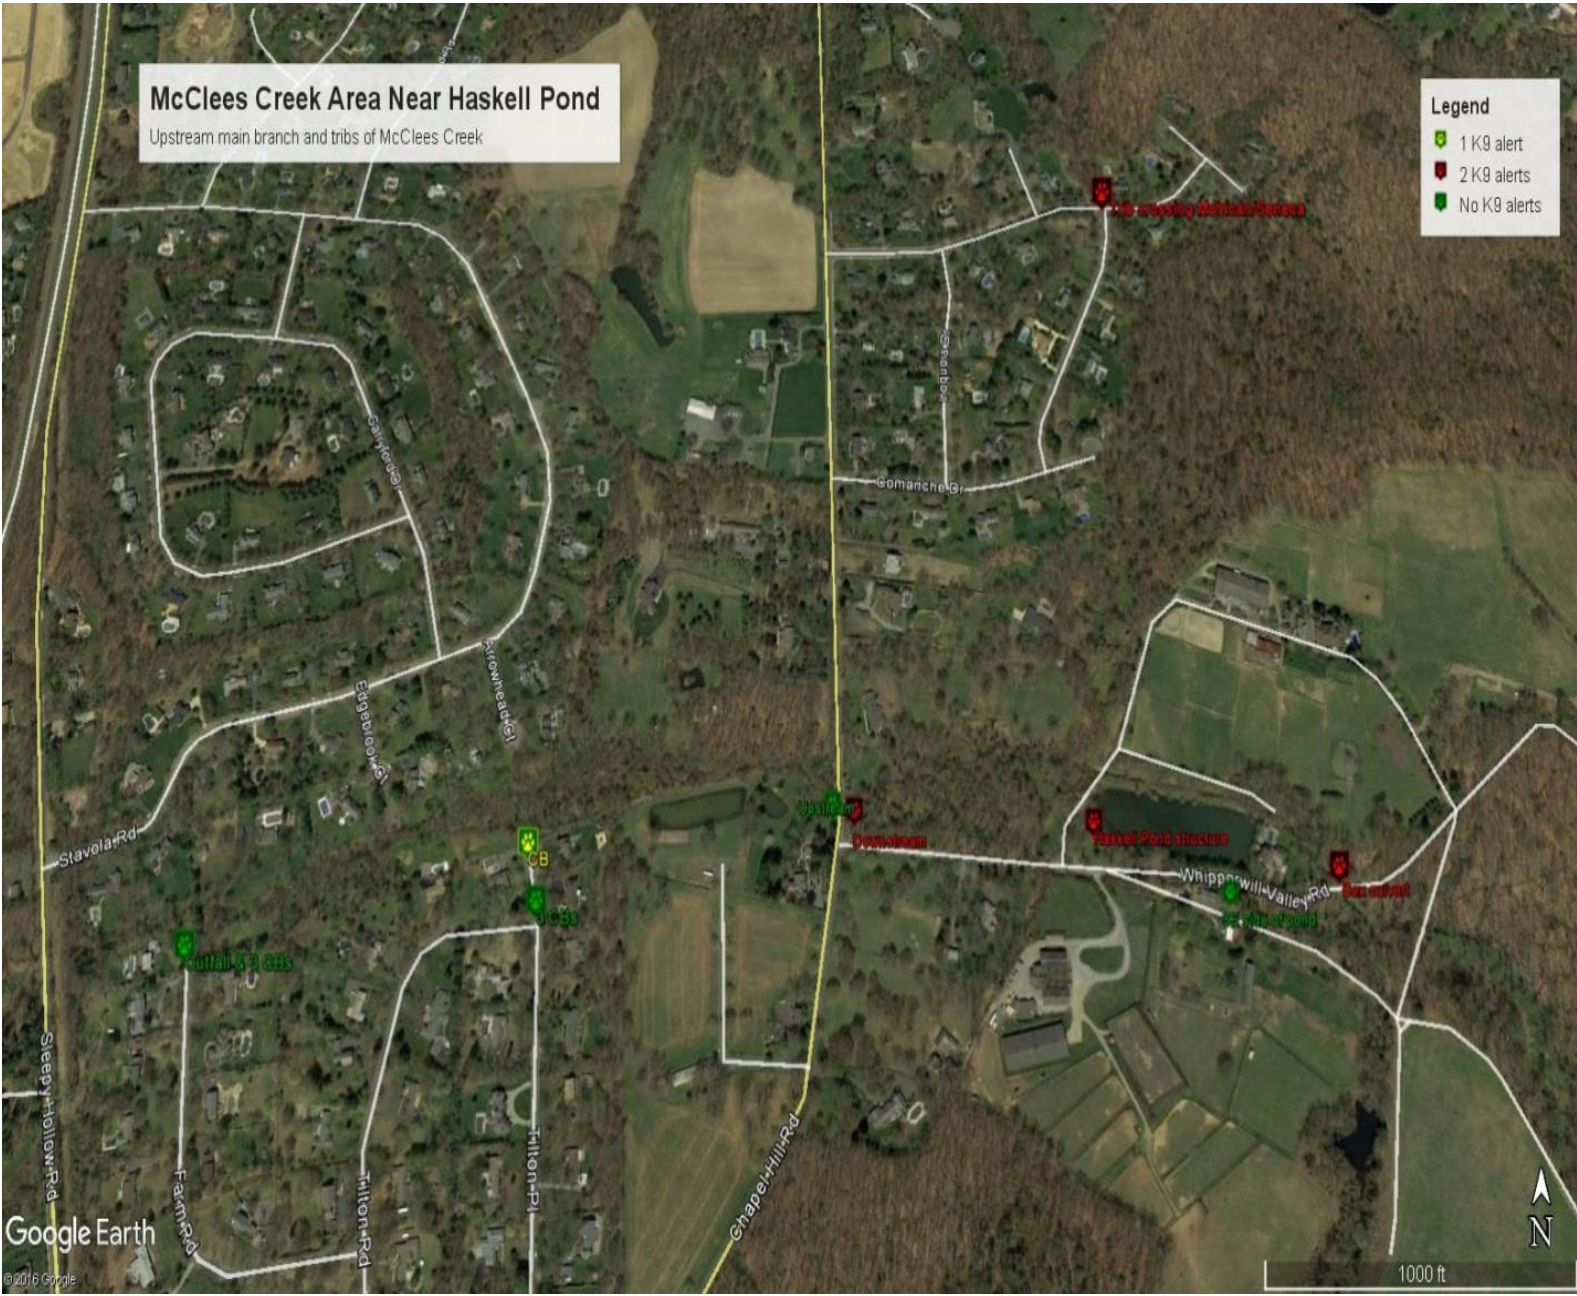
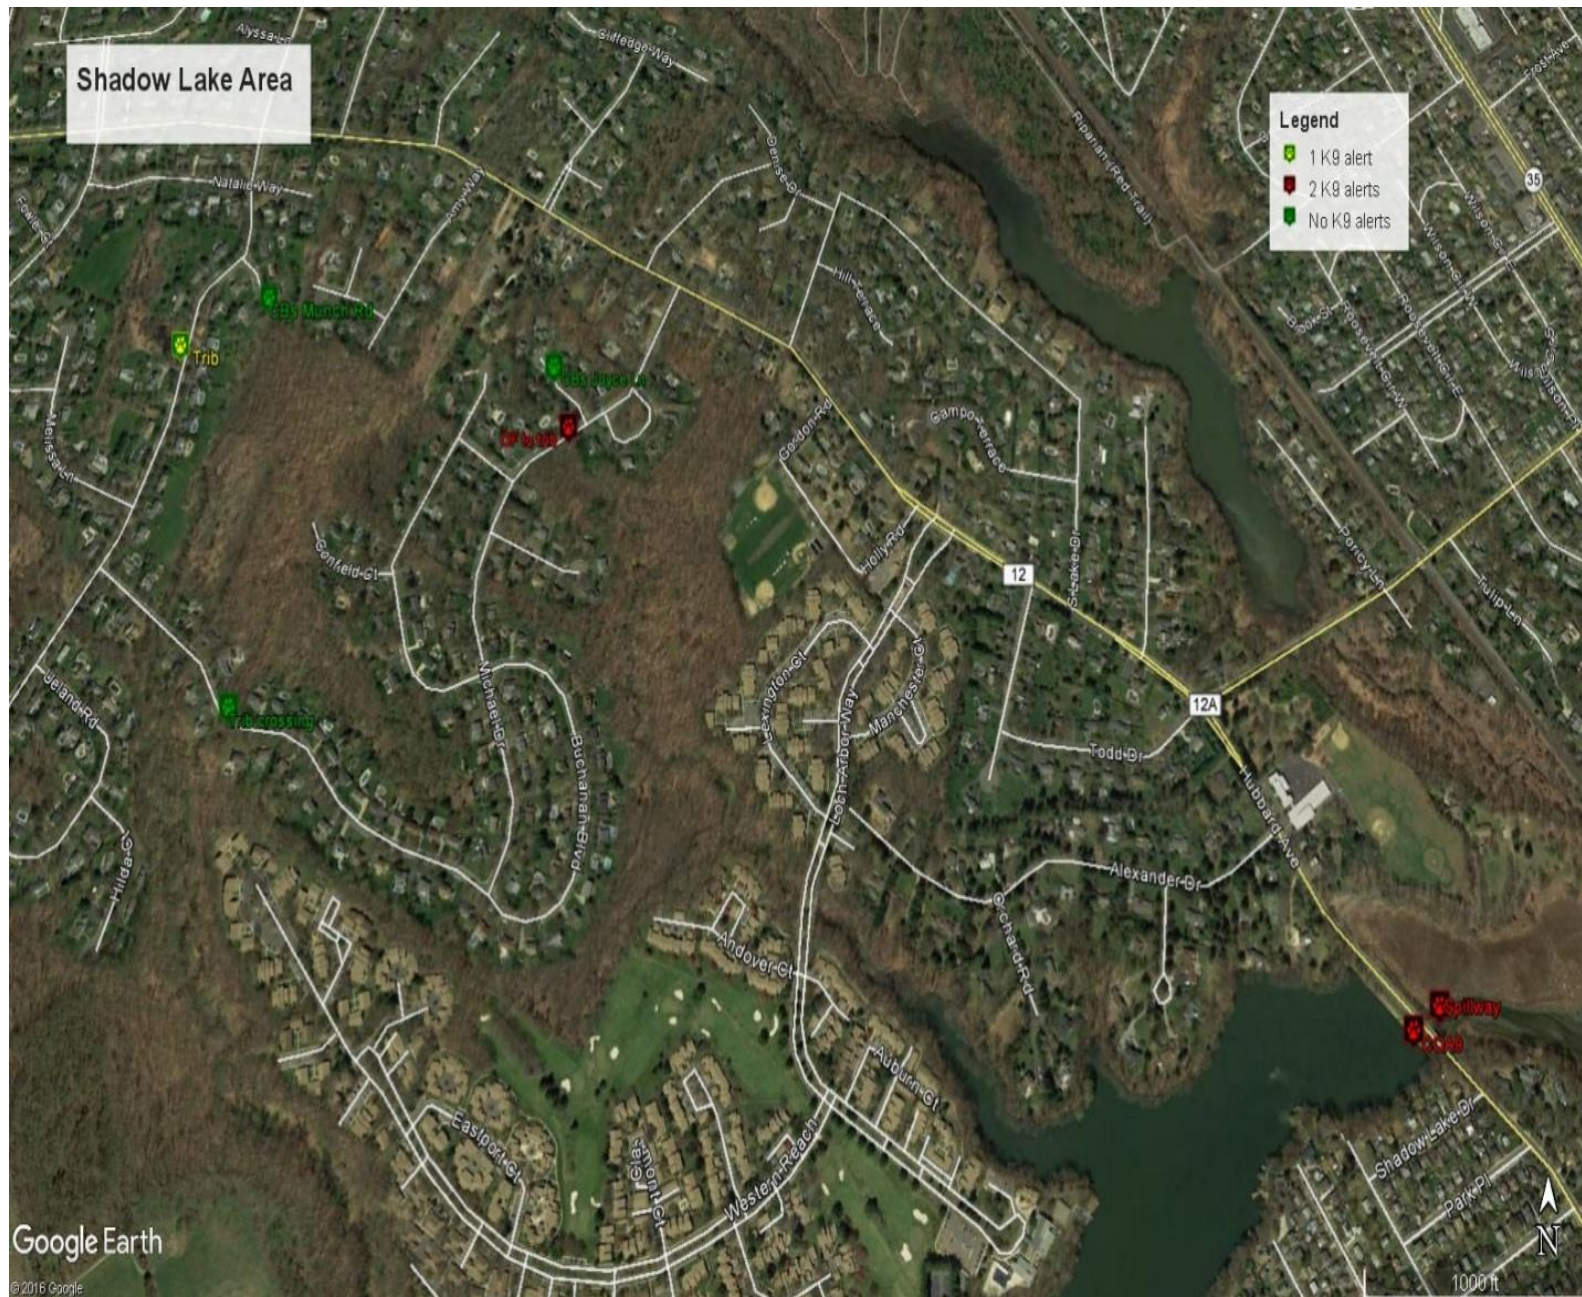
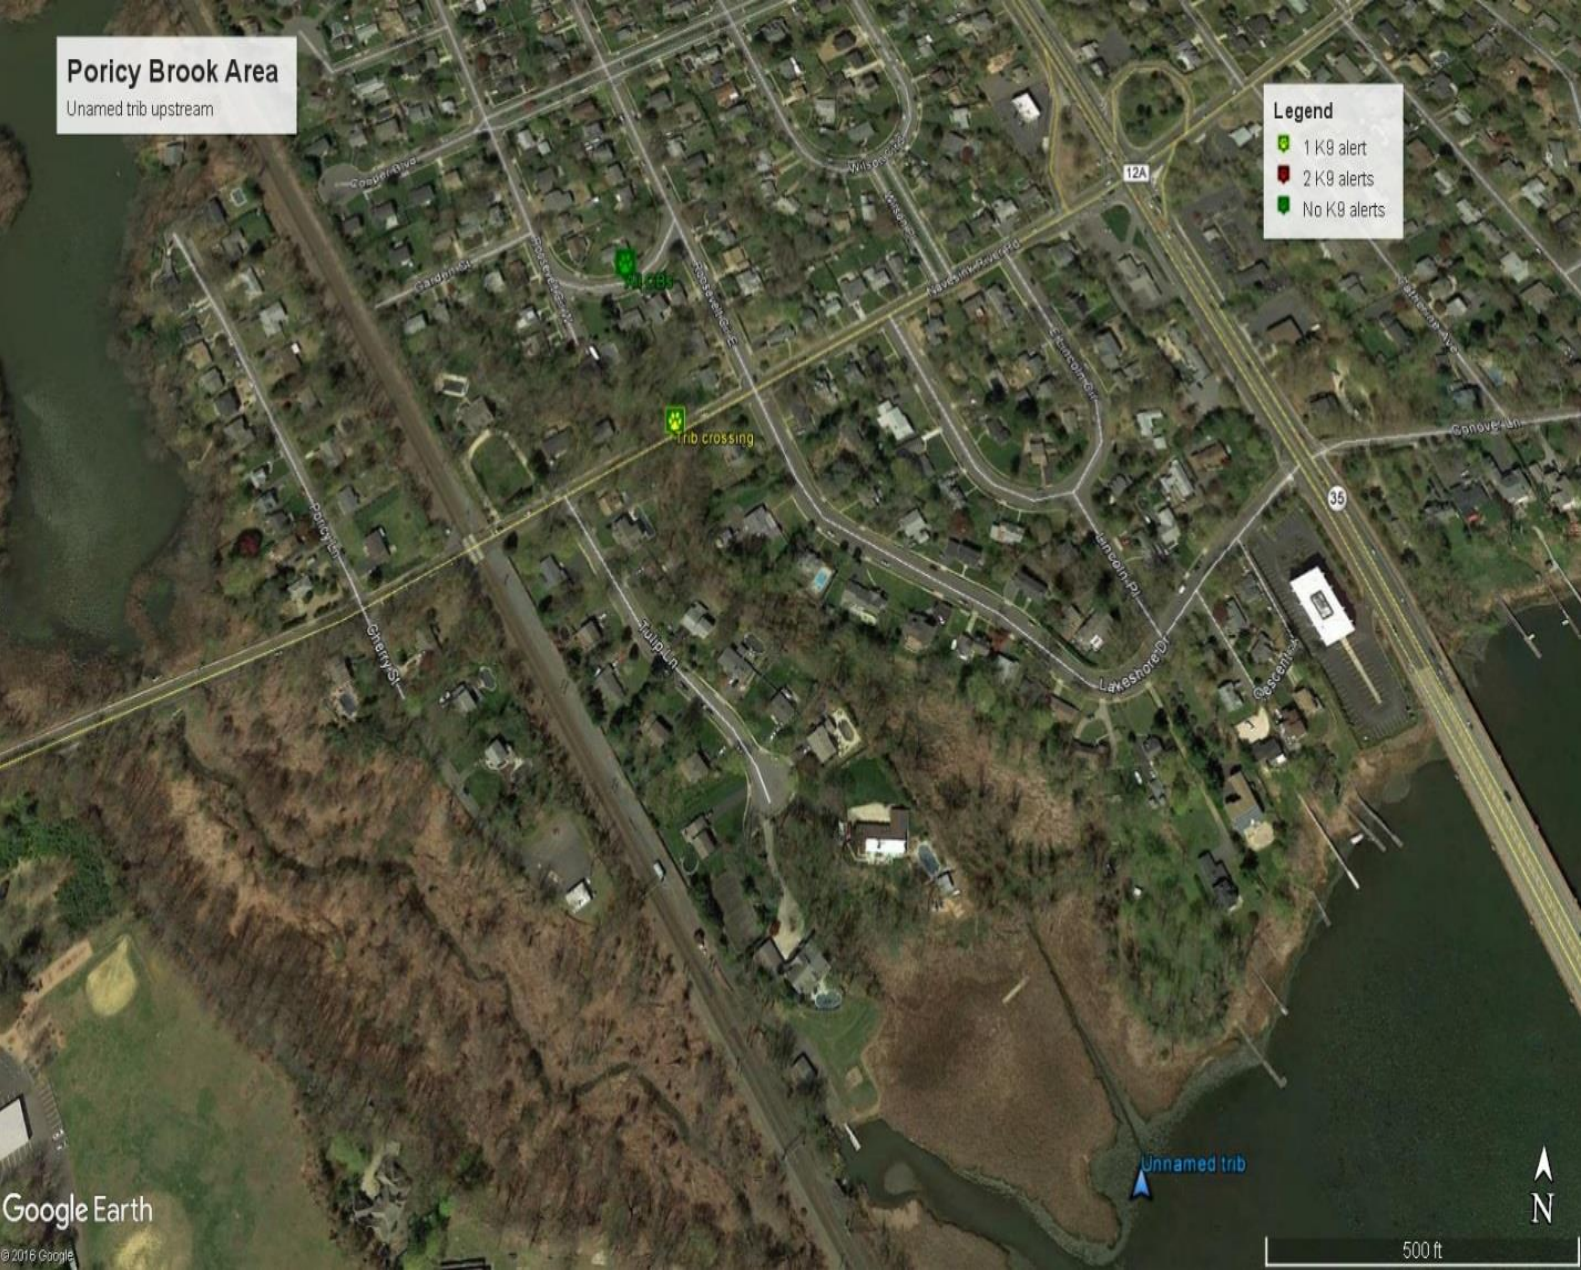
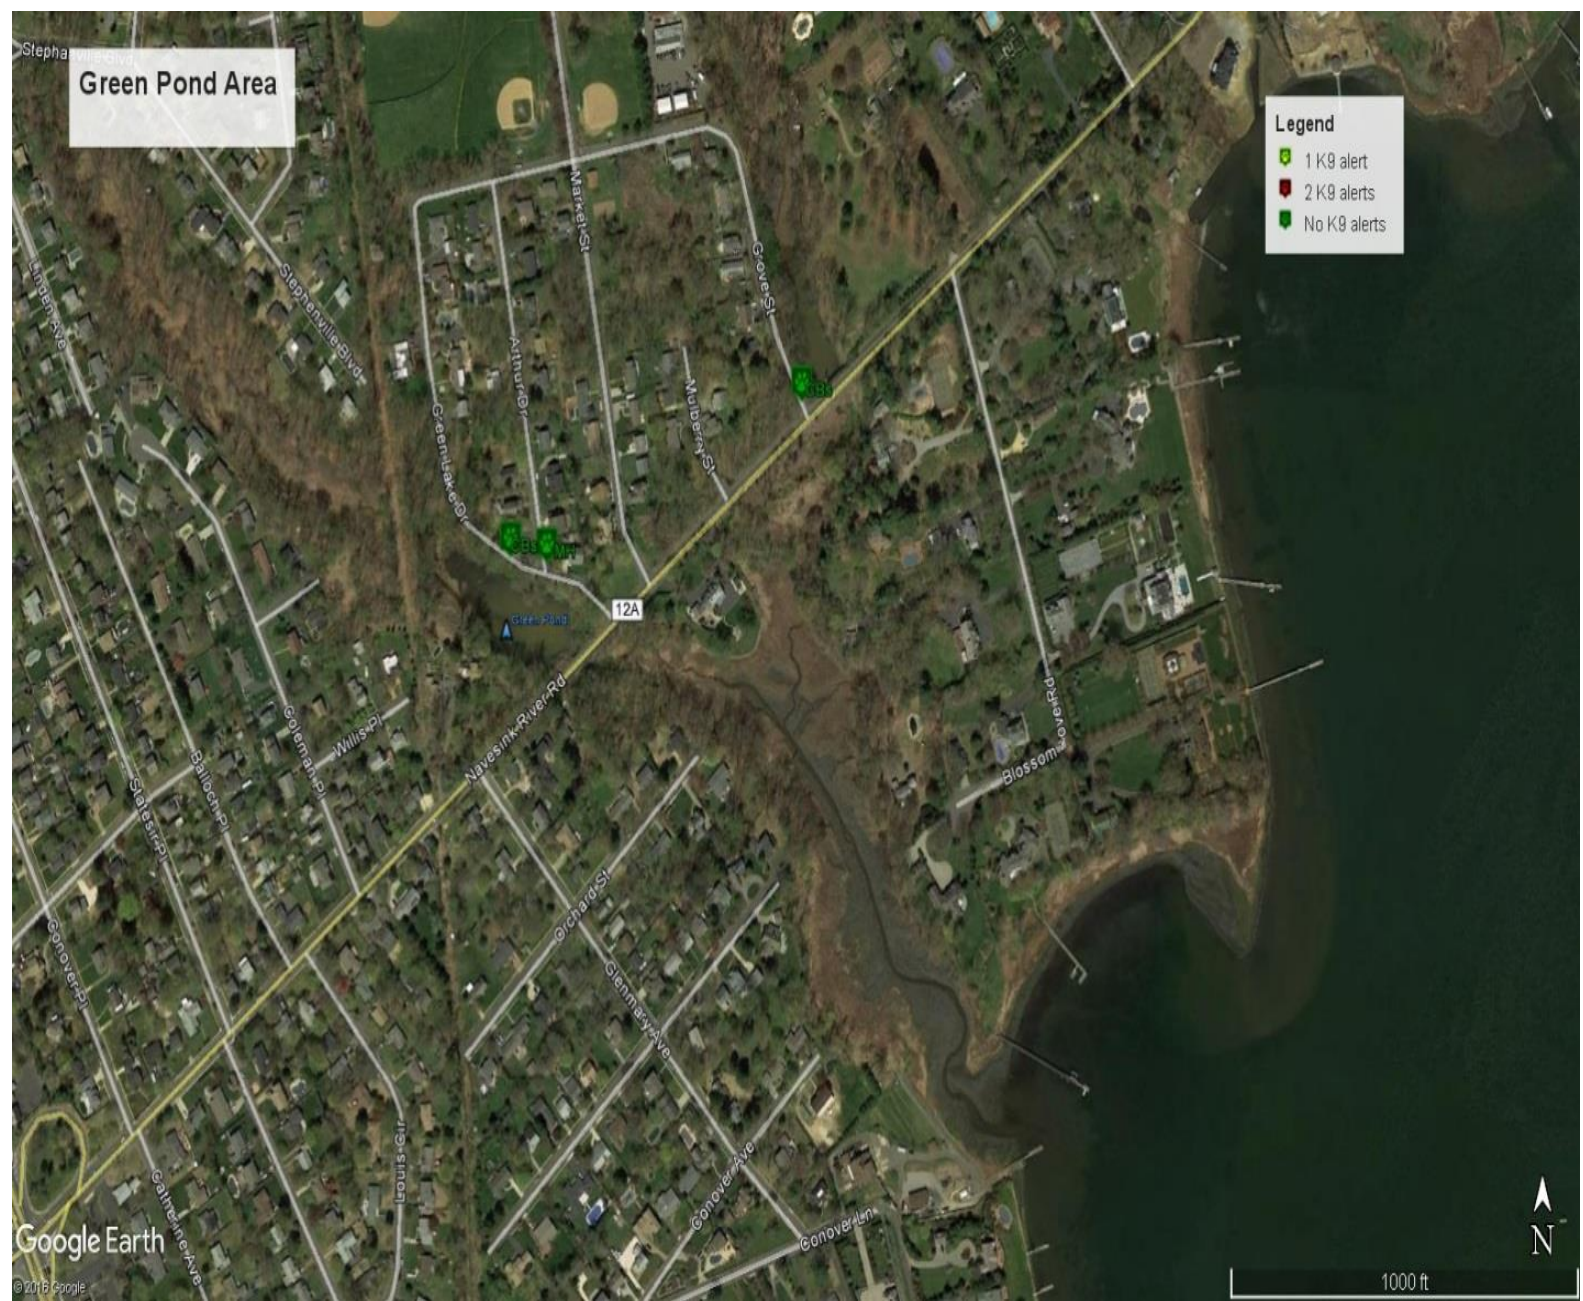
Maps of Canine Investigation Results in Middletown

Canine responses to each area investigated were mapped on Google Earth and analyzed along with the maps of outfalls and sewer and septic areas provided by Middletown to determine where source tracking had either isolated or eliminated potential sources. The summary of these findings and recommendations and canine result maps are provided below:
